# MAINTENANCE OF PHOTOVOLTAIC INSTALLATIONS USING INFRARED THERMOGRAPHY TECHNIQUES

Dr. Germán Álvarez Tey University of Cádiz November de 2022

## APPLICATION OF THE INSPECTION PROCEDURE TO A REAL PV INSTALLATION Basic data of PV plant to be inspected

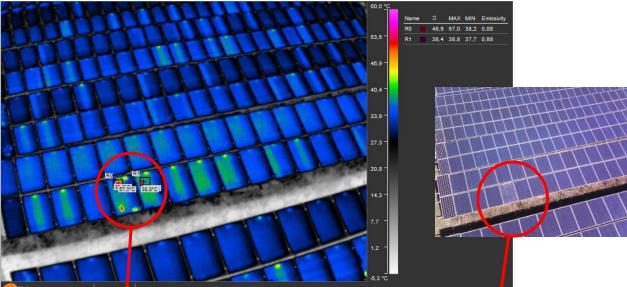
## APPLICATION OF THE INSPECTION PROCEDURE TO A REAL PV INSTALLATION Analysis of results - PV module glass breakage type incidents

- Location D10
- Tmax = 86.0 °C
- Tmed = 60.1 °C
- Point type abnormality.

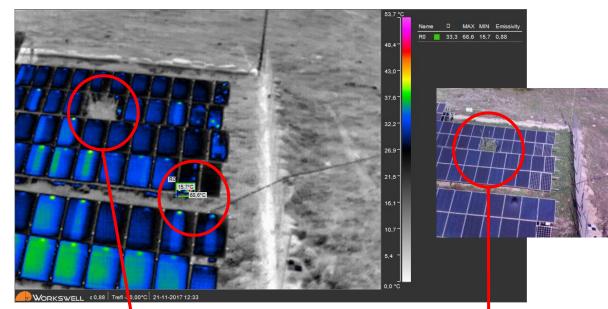
#### APPLICATION OF THE INSPECTION PROCEDURE TO A REAL PV INSTALLATION Analysis of results - Partial shading type incidents

- Location AQ4 and AR4
- Tmax = 49.6 °C
- The separation of the vegetation causes a moving shadow depending on the position of the sun.

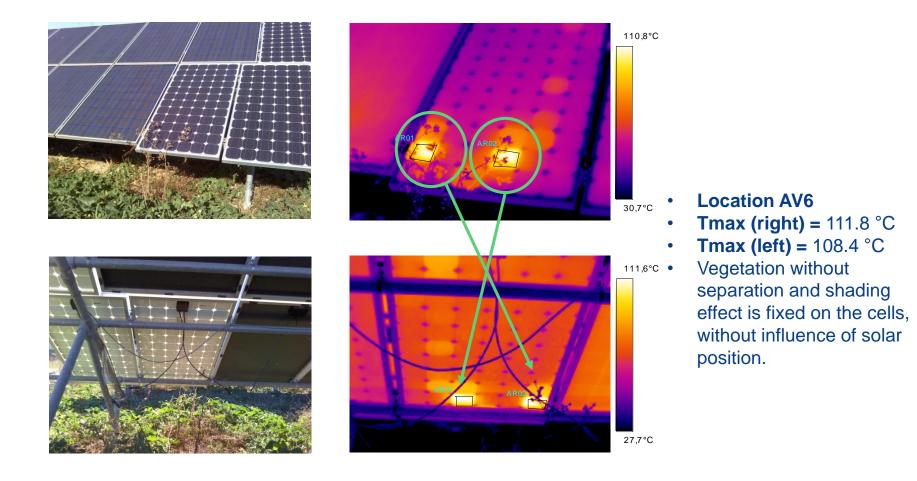
## APPLICATION OF THE INSPECTION PROCEDURE TO A REAL PV INSTALLATION Analysis of results - Partial shading type incidents

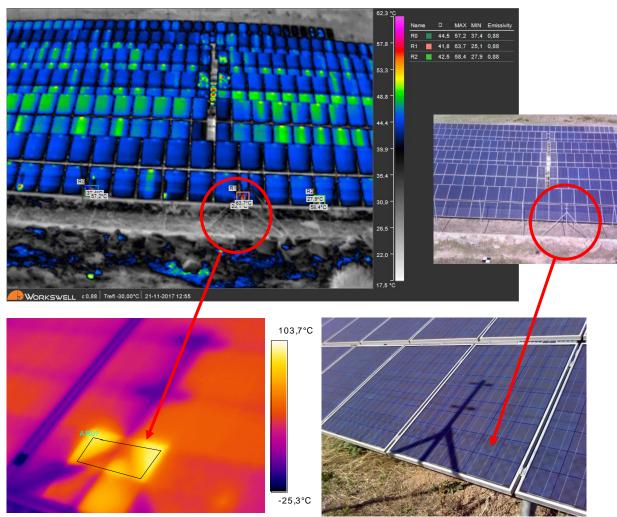
## APPLICATION OF THE INSPECTION PROCEDURE TO A REAL PV INSTALLATION Analysis of results - Partial shading type incidents

- Location AC12 (Array 6)
- **Tmax =** 77.5 °C.
- **Tmed =** 56.2 °C.
- This shadow moves with the movement of the sun so the value changes with time

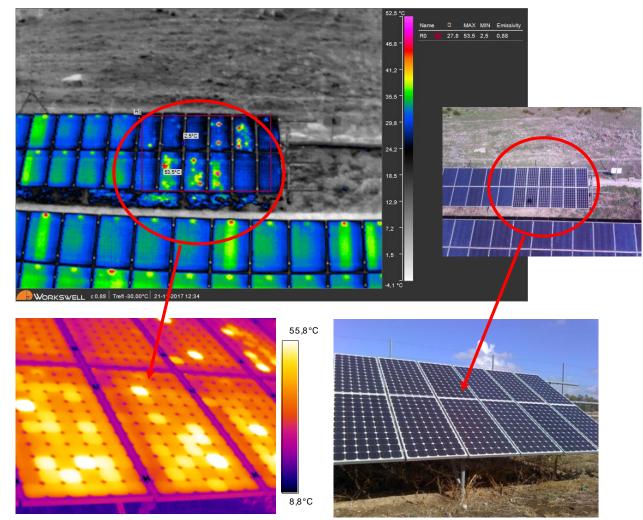
## APPLICATION OF THE INSPECTION PROCEDURE TO A REAL PV INSTALLATION Analysis of results - PV module technology type issues

- Si-m PV modules (Array 1) show an irregular pattern Tmax = 53.5 °C.
- This pattern is characteristic of a short-circuited module.
- In Si-m type module its lsc = 5.22 A is lower than the Imp = 7.57 A of Si-p type module.

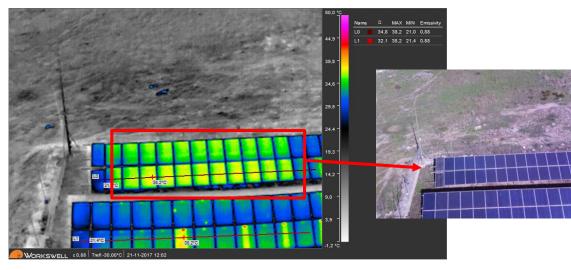
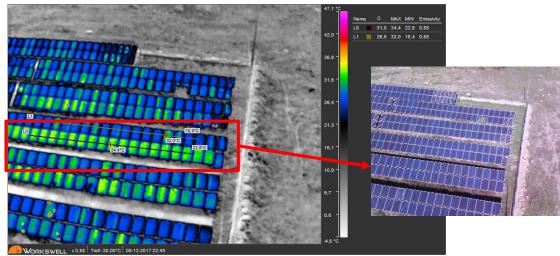
## APPLICATION OF THE INSPECTION PROCEDURE TO A REAL PV INSTALLATION Analysis of results - Open-circuit PV module type occurrences

- The string seen in Array 1 is in open circuit.
- The string seen in Array 4 (bottom) is in open circuit.
- They are overtemperature above 5°C.

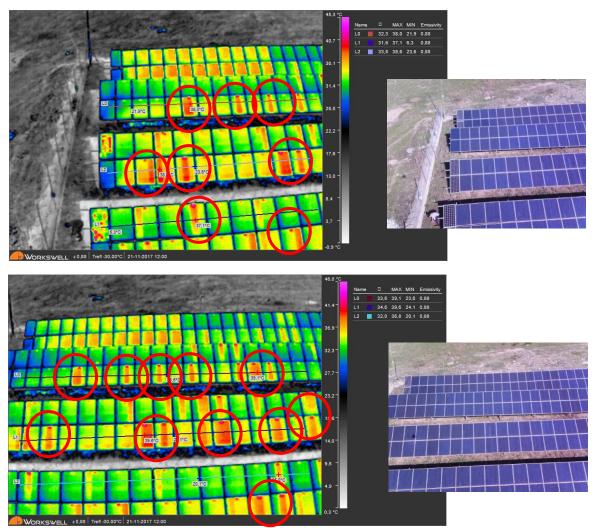
## APPLICATION OF THE INSPECTION PROCEDURE TO A REAL PV INSTALLATION Analysis of results - Other incidences

- Several PV modules have open-circuit substrings on Arrays 1, 2, 3 and 4.
- The maximum temperatures are reached in the upper area of PV modules (diode box) with values above 45 °C.
