# MAINTENANCE OF PHOTOVOLTAIC INSTALLATIONS USING INFRARED THERMOGRAPHY TECHNIQUES

Dr. Germán Álvarez Tey University of Cádiz November de 2022

## APPLICATION OF THE INSPECTION PROCEDURE TO A REAL PV INSTALLATION Basic data of PV plant to be inspected

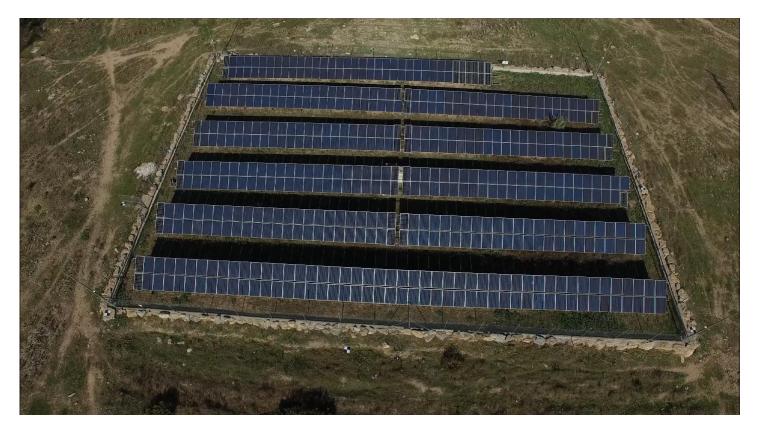
- \* Rated power: 100 kW
- \* Location: South SPAIN ; Coordinates: latitude: 36.85°N, longitude: -5.59°O
- \* Orientation South / Inclination: 32°
- \* **PV module technology:** Si-p type, later some Si-m types

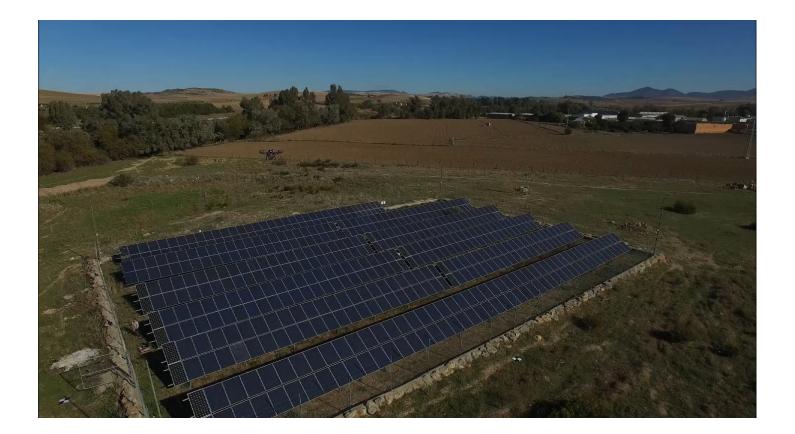
- IR inspection type 1st scan: Aerial with Workswell WIRIS 2nd 336 IR camera housed in drone.
- **IR inspection type 2nd sweep:** On the ground with Flir ThermaCam S60 camera.

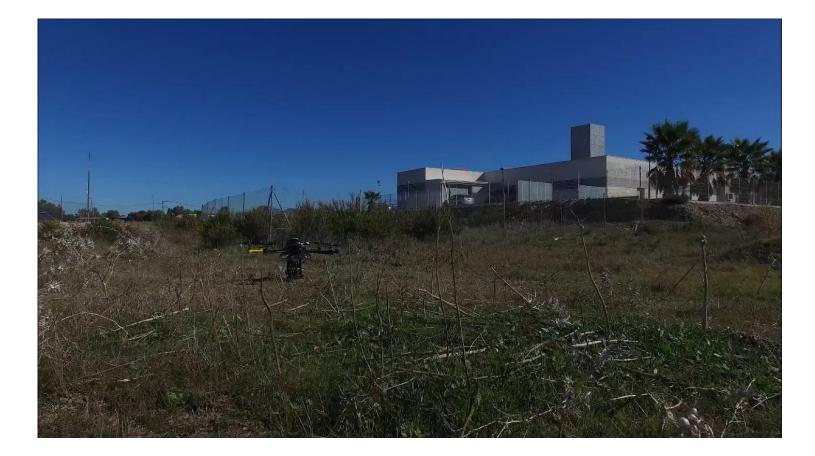
- \* Cloud cover : 0 okta (clear sky); Wind speed < 1 m/s; Flat irradiance modules > 890 W/m<sup>2</sup>
- \* Atmospheric temperature: between 24 and 26 °C; Relative humidity: 28/30 %RH

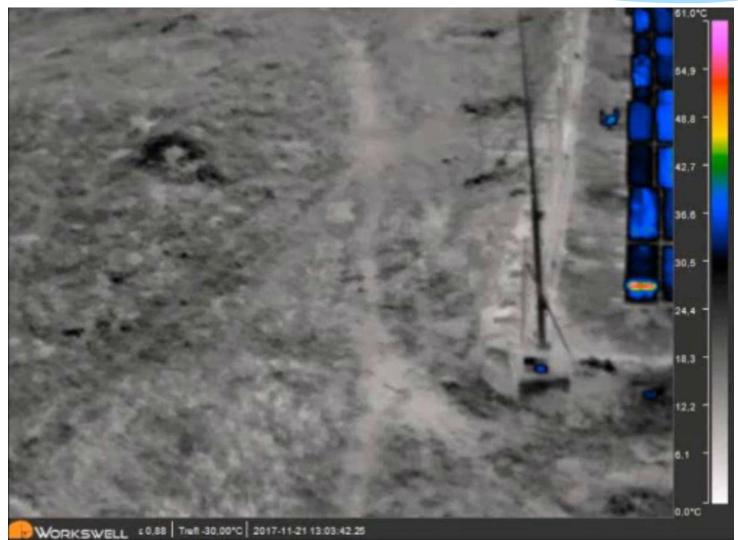
## APPLICATION OF THE INSPECTION PROCEDURE TO A REAL PV INSTALLATION Analysis of results: Thermographic video obtained in the PV plant is reproduced
